Case Study

Rust Free - using outstanding anti-corrosive waterborne coat as part of paint system for maintenance

**Goliath
Leader**

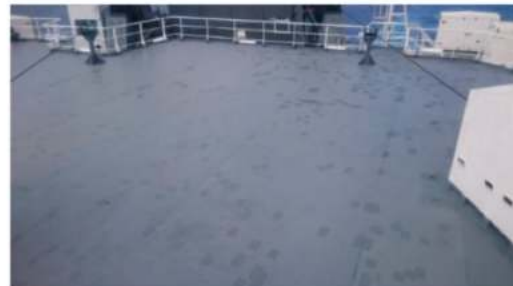
Upper deck after treatment

The outdoor surfaces of the vessel were prepared by high pressure (100-200 bars) water cleaning to remove all loose paint, mill scale and rust. Once the surfaces were dry, the crew used a Rust Free coat over the stable rust and old paint. The product has a low VOC (Volatile Organic Compound) level ~0 enabling the crew to work without any special protective equipment even in unventilated areas. In the end, they returned the product to its original package for later additional uses and within 24hrs, they had covered the Rust Free layer with common top paints which are used on vessels.

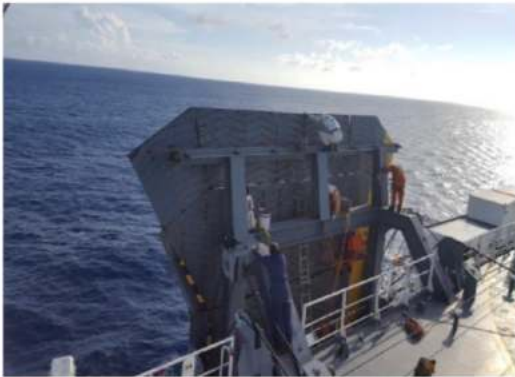
Surface preparation - high pressure water

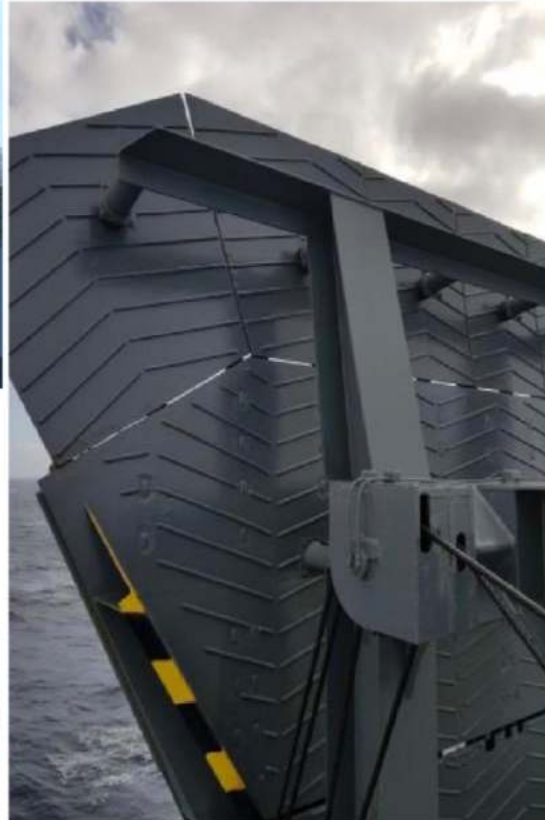
Vehicle carrier side ramp during maintenance
