Case Study

Rust Free - using outstanding anti corrosive waterborne coat as part of paint system for tank floated roof maintenance

Ponton Floated Roof - Oil Storage Tank

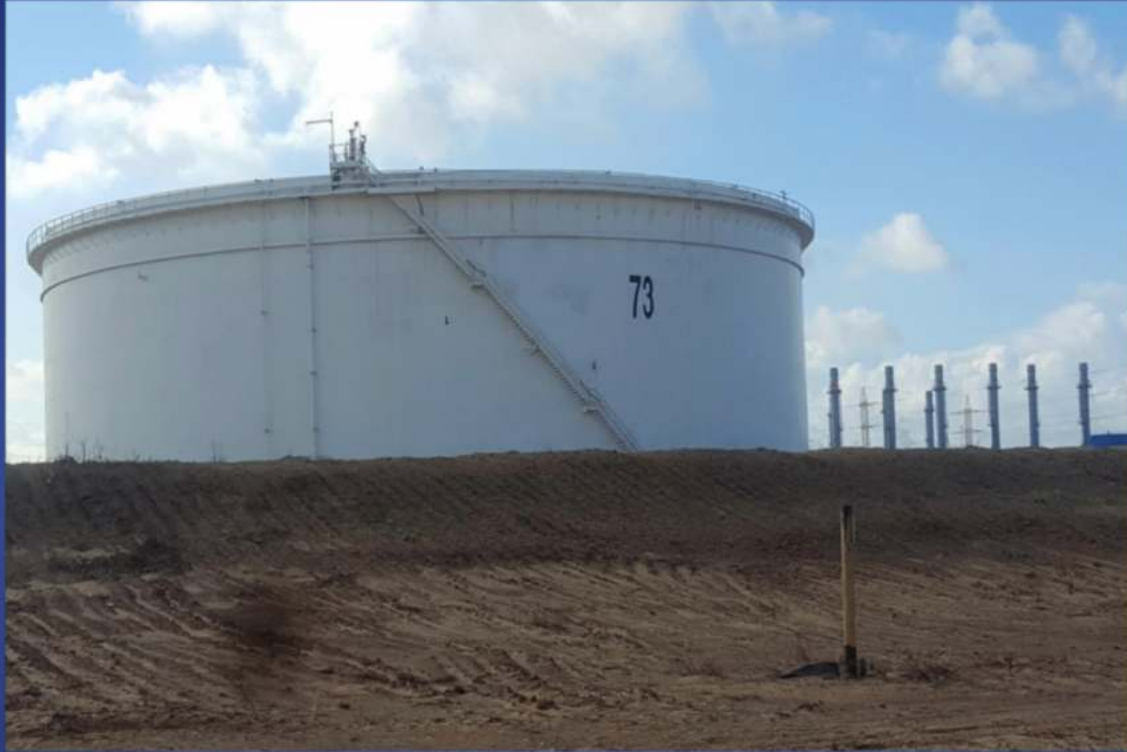
Floated roof initial condition

The surface of the float roof was cleaned by high pressure water jetting (over 500 bar) to remove old paint and loose metal. Once the area was dry, **Rust Free was applied** with a spray over the old paint. The required WFT was fifty microns. Rust Free has white-off white color (the old top paint was white). A pigment was added to the product to verify that all surfaces had been coated. Twenty-four hours later, a new polyurethane top paint layer was applied to complete the customer paint system requirements. Gloves and protective glasses were the only personal protective equipment required, even respiratory masks were not necessary.

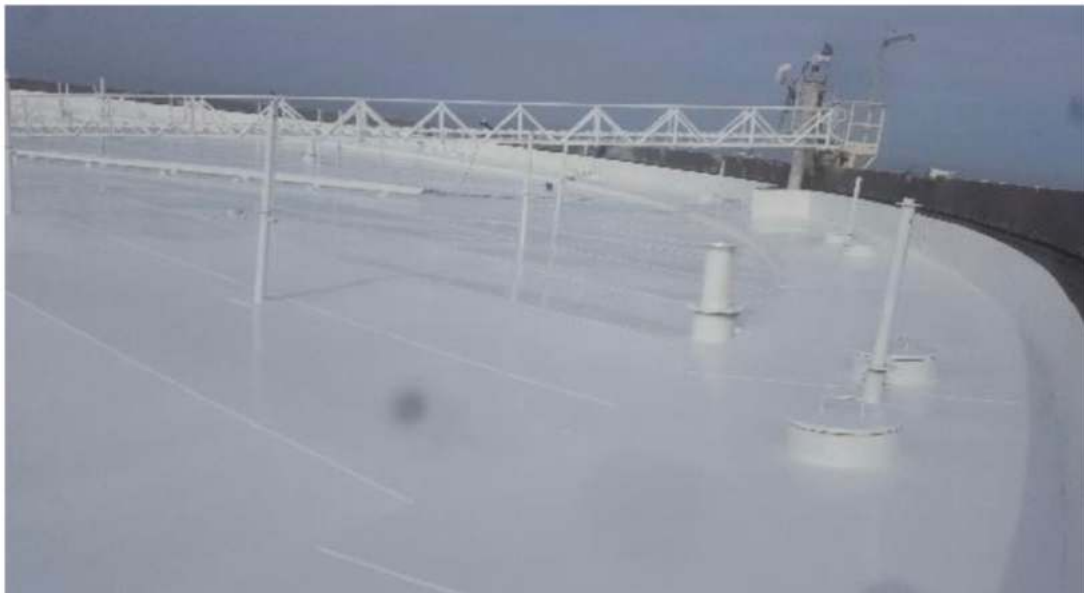
Floated roof appearance after polyurethane top paint

After over a year, the floated roof is in excellent condition. There is no sign of rust or paint lamination. Also, the DFT remains the same and the adhesion is very good.
