# Case Study

Rust Free - using outstanding anti-corrosive waterborne coat as part of paint system for maintenance.

Warehouse  
Construction

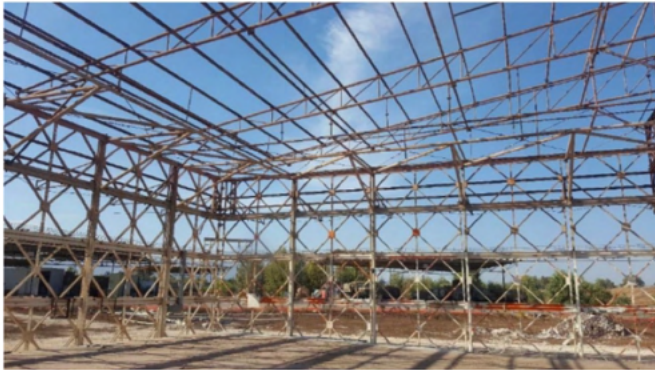
shed condition before treatment

A steel warehouse construction which has not been treated in many years – only renewed the top layer in reachable areas. The rusty condition of the shed had to be treated immediately due to the mechanical strength of the metal itself. In November 2016, Treatment of the shed began and included pre-treatment with high pressure water jetting to remove loose rust and old paint that began to peel off.

The surface preparation was done by high pressure water cleaning (100-200 bars) to remove all loose paint, mill scale and rust. Once the surface dried, the maintenance crew used Rust Free coat over the stable rust and old paint. The product has lower VOC (Volatile Organic Compound) ~0 enabling the crew to work free of any special protective equipment against fire. In the end, the product was returned to its original package for additional future uses. Twenty four hours later, they covered the Rust Free layer with their common top paints on site.

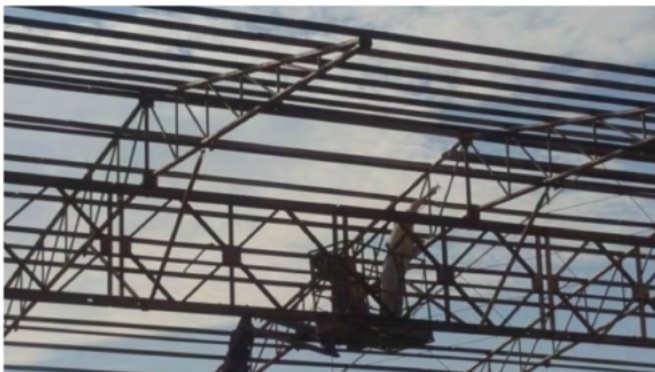
Single layer application with Airless

Once the surface had dried, treatment with the Rust Free began. When the material dries, it becomes transparent, so we add red pigment to the surface material to ensure full application where the paint remains white. Once the base coat finished, the shed was painted with a top coat according to the customer's request. More than a year and a half later, the shed remains in good shape.

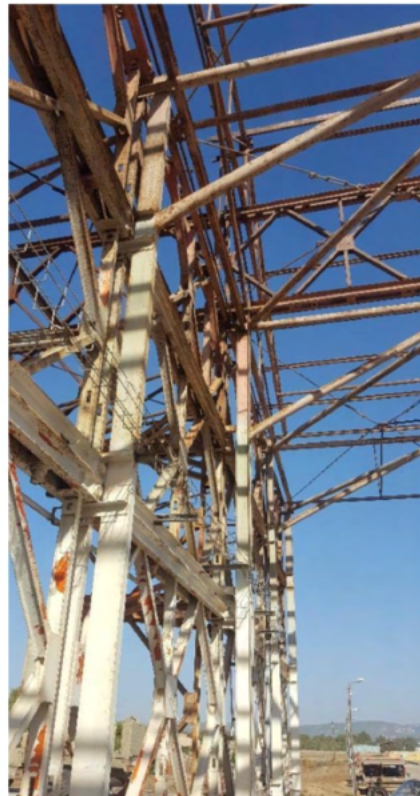
shed condition before treatment

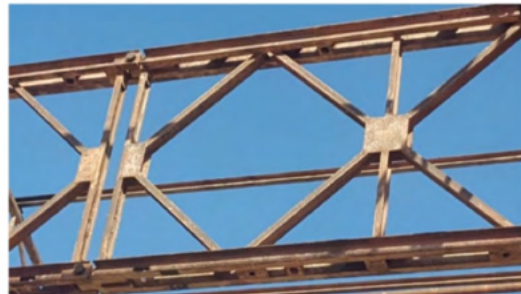
Warehouse's complexity element

This storage area requires availability 24 hours a day. The treatment of this complex old shed had to be carried out as quickly as possible. In addition, surface preparations by any abrasive blasting in this area was prohibited, as the surrounding environment was flammable, and all paints required a very low VOC. A long-term solution, using durable materials was required.

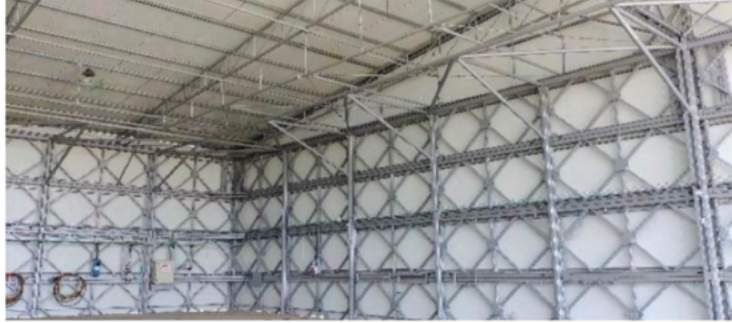
The shed, with a full paint system is in very good condition. No signs of rust spots inside or outside the shed.

shed condition after treatment

According to the site maintenance manager: *"The paint system with the Rust Free is withstanding great and no any traces of rusty processes observed. The adhesion to the old paint is also very good".*
